## TEST REPORT

RFK 600 15KΩ REINFORCED INSULATION REV. D3  
TESTS: HEATING, RAIN, MOISTURE AND SALT MIST

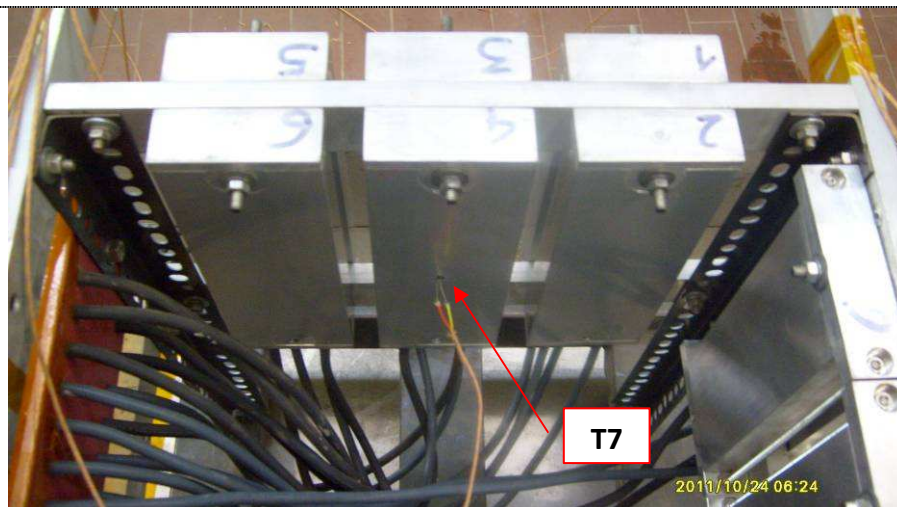
Details about TIE-BEAM mounting

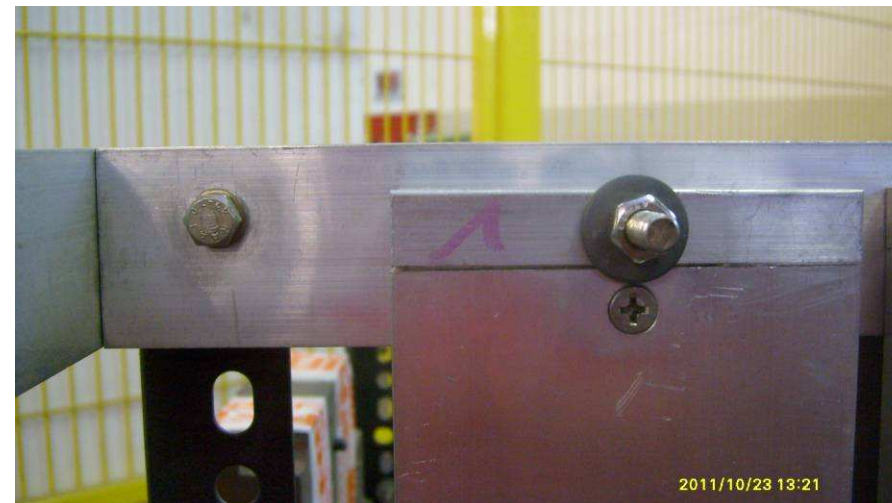
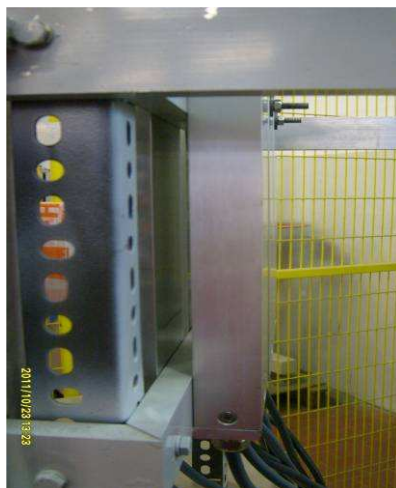
Details about D3 mounting

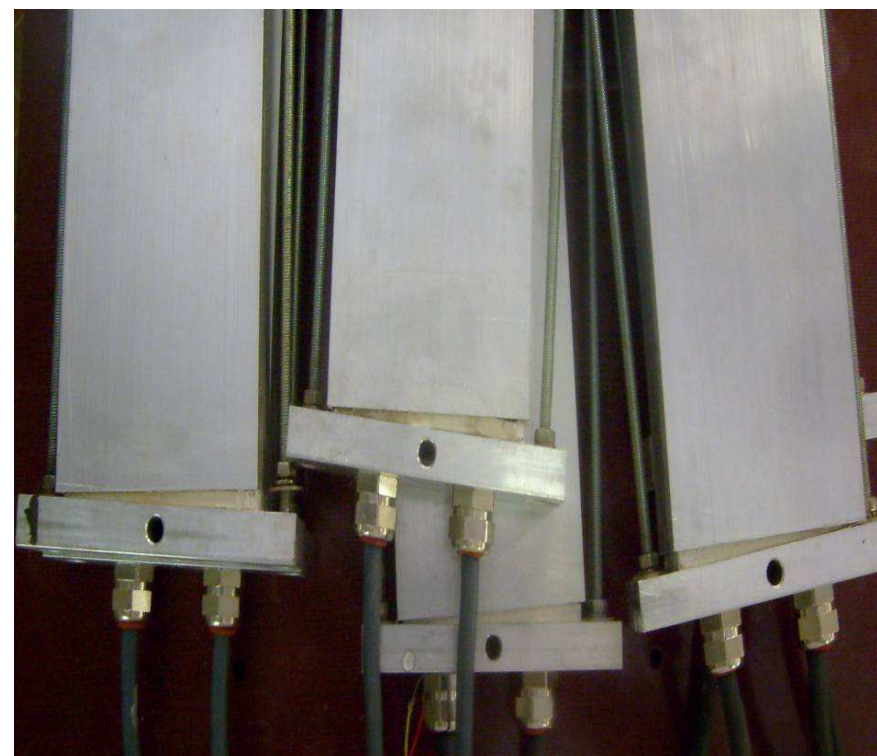
A failure in all TIE-BEAM configuration was observed after heating test (as you can see in the pictures reported here above): the cap has been disassembled by the enclosure due to the expansion of the air inside. **TIE-BEAM configuration has not been tested in the following steps of the present campaign.**

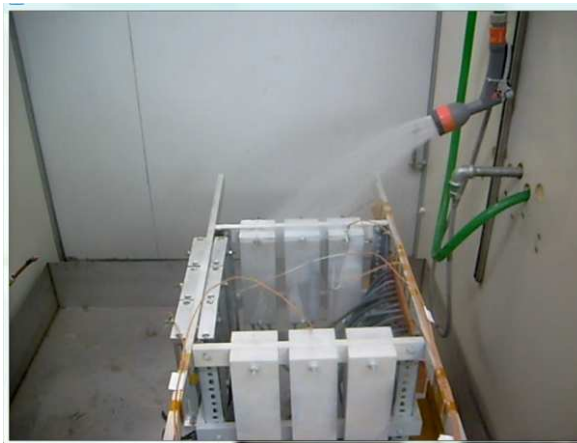
**7.5 Pictures during rain test**

The resistors are brought to a nominal working temperature by application of an appropriate power; the resistors' enclosures were then sprayed with water for 1 minute with a flow rate of approximately 1 liter per minute.

This procedure was carried out three times. At the end of the trial, the measurement of the insulation resistance was carried out in two different moments: immediately after rain test and after 15 hours.

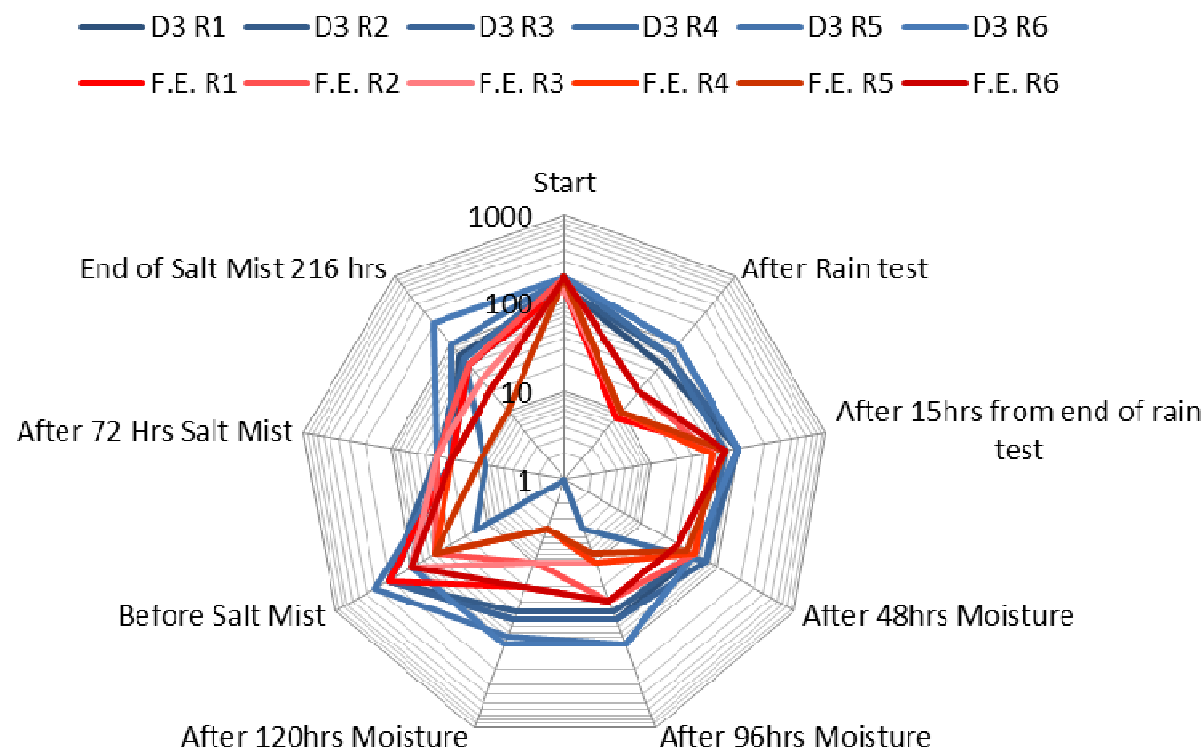
## Insulation resistance behaviour (1000 Vdc - values in G $\Omega$ )

- **EXTERNAL HOLE configuration** has passed all the test in the present campaign;
- **D3 configuration** has passed all the test in the present campaign;
- **D3 configuration** will be adopted as new **STANDARD CONFIGURATION** because the higher values (compared to EXTERNAL HOLE configuration) of the insulation resistance measured after each test could permit higher safety margin in term of ageing effect or critical operating conditions. The graph reported in the following page can explain in a simple way the reason of this choice.
